# Manhole Inspection Summary

Manhole # S15C\_\_034MH

Insp Date: **7/28/09 11:20 AM**

**Location** Address: **2594 EDMONSON AVE**

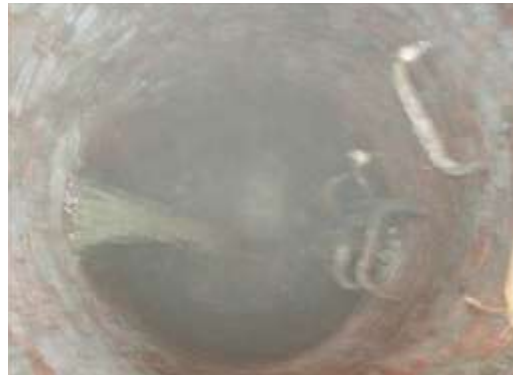
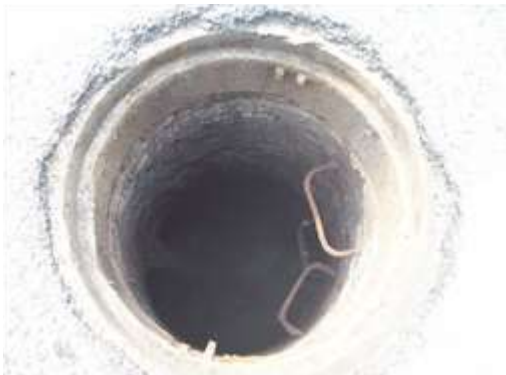
**Too Much Steam - Cannot Get Better Top View With Clear Connectivity - Multiple Field Visit**

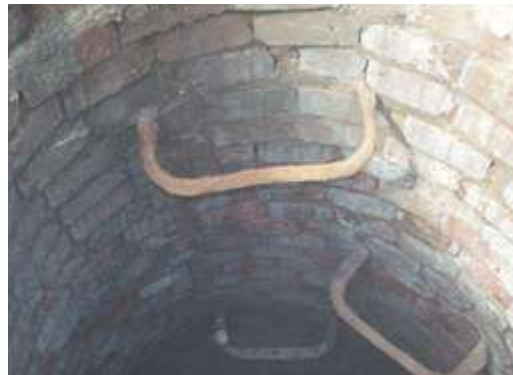
Defect 1

Count: **12** Missing: **0** ☒ **Corroded**

CORRODED STEPS

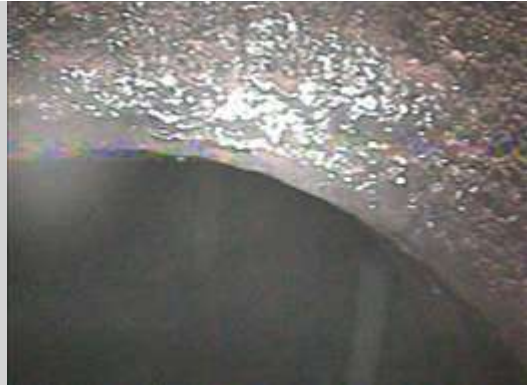
12 O'Clock Outflow

33 in. Circular Gravity Sewer  
Pipe Out @ 12 O'Clock

Pipe Height: (in.) Direct  
Pipe Material: **Clay** ☐ Pipe Lined  
Invert Depth: **19.15** (ft.) Flow Characteristics: **Fast**  
Deposits: ☒ None ☐ Mud ☐ Sludge ☐ Debris ☐ Grease  
Silt Depth: (in.) Deposits Extent:  
Infiltration: **None** Pipe Seal Cond: **Sound**

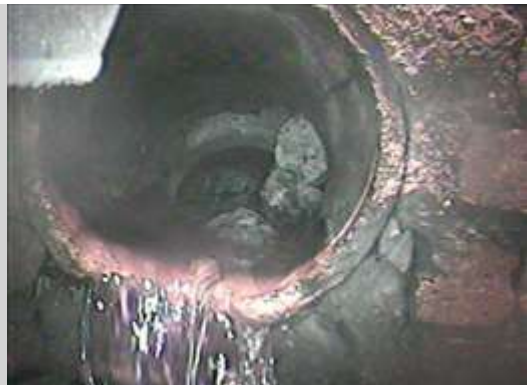
3 O'Clock Inflow

8 in. Circular Gravity Sewer  
Pipe In @ 3 O'Clock

Pipe Height: (in.) Direct  
Pipe Material: **Clay** ☐ Pipe Lined  
Invert Depth: **8.82** (ft.) Flow Characteristics: **Fast**  
Deposits: ☒ None ☐ Mud ☐ Sludge ☐ Debris ☐ Grease  
Silt Depth: (in.) Deposits Extent:  
Infiltration: **None** Pipe Seal Cond: **Sound**

Drop: **Outside Direct**  
Angled: Reading: (ft.)  
Inv Depth: **17.98** (ft.)

Drop Condition: **Open**

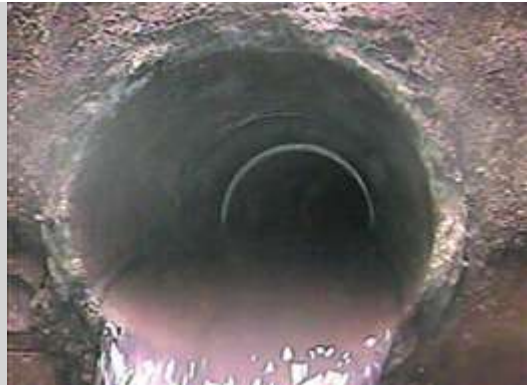
6 O'Clock Inflow

33 in. Circular Gravity Sewer

Pipe In @ 6 O'Clock

Invert Depth: **19.14** (ft.) Flow Characteristics: **Fast**

Infiltration: **None** Pipe Seal Cond: **Sound**

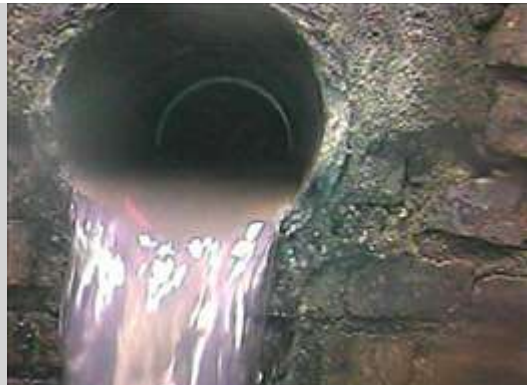
9 O'Clock Inflow

8 in. Circular Gravity Sewer

Pipe In @ 9 O'Clock

Invert Depth: **6.34** (ft.) Flow Characteristics: **Fast**

Infiltration: **None** Pipe Seal Cond: **Sound**

Drop: **Outside Direct**

Inv Depth: **17.72** (ft.)

Drop Condition: **Open**
